City of Florence, South Carolina

Sewer Collection System Master Plan

September 2025

Sewer Collection System Master Plan City of Florence

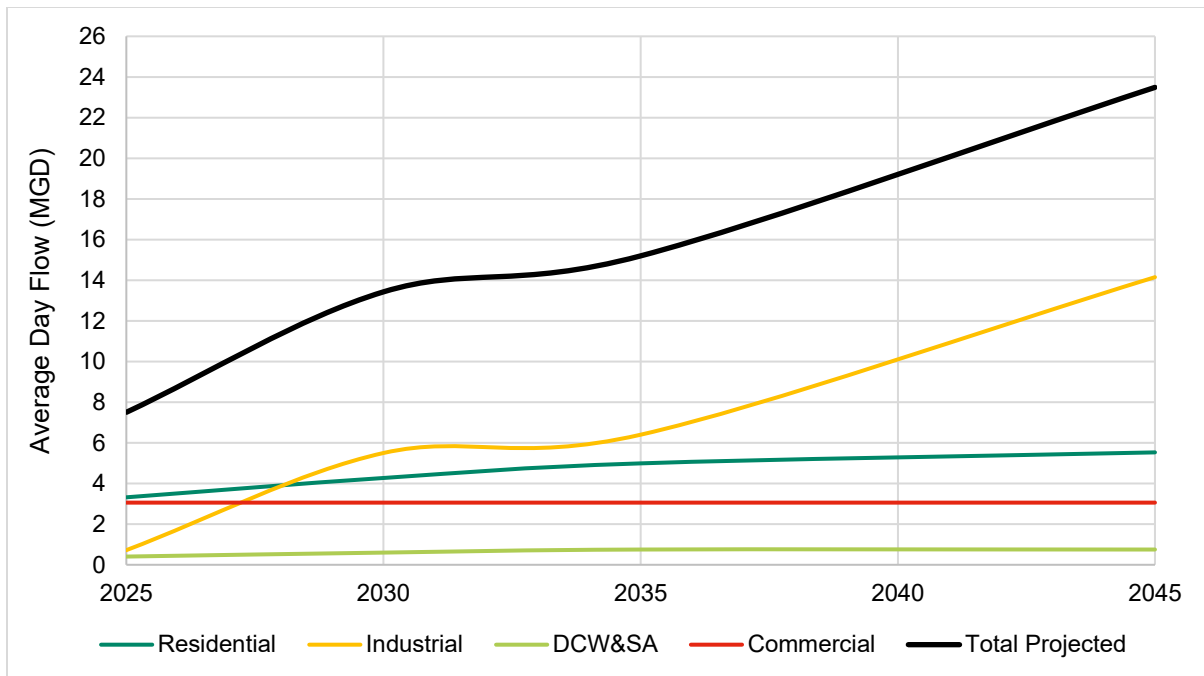
Figure 3-3: Flow Projections By Customer Class, 2025-2045

Table 3-6 and **Figure 3-3** present the projected flows for the short term (2030), intermediate (2035), and long term (2045) planning horizons based on the methodology described in the previous sections. The majority of future sanitary flow increases are attributed to the 13.43 MGD increase from industrial users, which makes up 60.2% of the total projected flow in 2045.

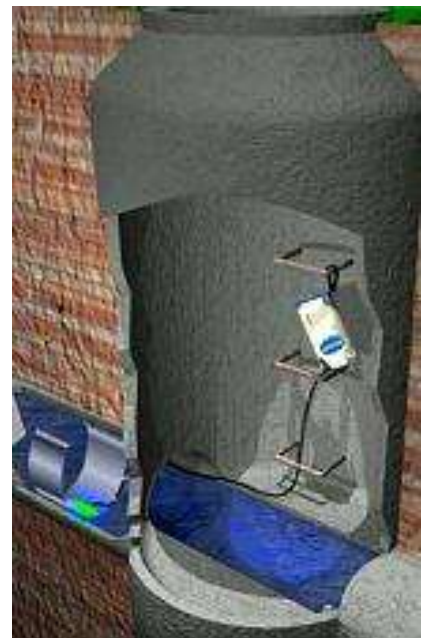
Figure 1: Typical Flow Monitor Installation in a Sewer Manhole

Eight locations were selected for flow monitoring. **Figure 1** shows an illustration of the typical flow monitor installation used during this study. Hach FL901 portable flow monitoring equipment was used to collect water levels and flow velocities. **Figure 2** illustrates the location of the flow monitors and associated tributary area.

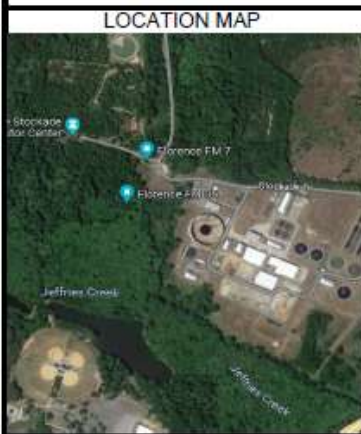
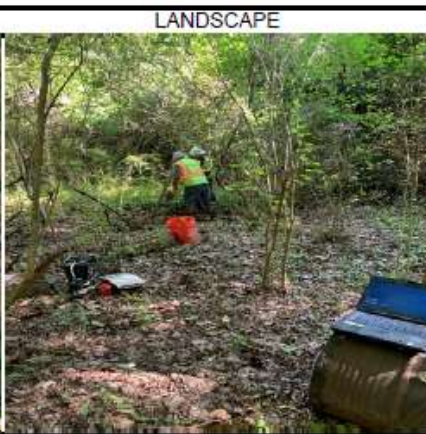
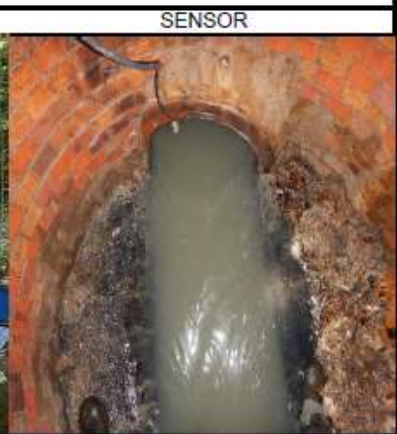
Project Name: COF Flow Monitoring		Install Date: 5/24/2023		Time: 9:00			
Project Job #: 60704377		Crew: BK SC					
Site Number/ID: FM 05		Location: Woods west of WWTP					
Location Description: Jeffries Creek South							
Type of Sewer:	Storm	Sanitary	Combined	Other:			
Tributary Area:	Residential	Commercial	Undeveloped	Industrial	Other:		
Manhole Conditions:	Good	Silting	Oil/Grease	Surcharged	Other:		
Manhole Type:	Over/Under	Dividing Wall	Standard	Junction	Bend Drop Overflow		
Pipe Construction:	VCP	Concrete	PVC	Brick	Other:		
Manhole Depth:	5.1' (FT)		Pipe Monitored (circle one) Inlet Outlet Overflow				
Evidence Surge:	Yes / No		Pipe Sizes:				
Flow Meter Information			Inlet:	Outlet:	Pipe 1: Pipe 2: Pipe 3:		
Meter Type:	FL901		24"	24"			
Vendor:	Hach		Flow Characteristics:				
Meter Serial Number:	2695		Stagnant	Turbulent	Laminar Dry Other		
Sensor Types:	Sub AV		Real Time/Current Status Readings at Installation

Sensor S/N:	174625		METER	Time:	UDepth PDepth/UDepth PDepth/UDepth		
Sensor Location:	Upstream			Depth (in)	11.54		
Velocity Direction:	NA			Velocity (fps)	2.39		
Data collection interval:	5 Minutes			Flow (MGD)	2.31		
			MANUAL	1	2	3	
				Depth (in)	11.5		
				Velocity (fps)	2.5		
				Physical Offset:	0	Electronic Pdepth:	0.51
Silt:	0	Level Adj:	Udepth:	0			
Vel Max fps:		Manual Velocity Profiling					
Velocity Gain:	1						
Calc. Manual Velocity:							
Telemetry							
Telemetry Used:	Yes / No		Coordinates:	34° 10.386 79° 45.120 Ant. Type Puck			
Ant. Location:							
Setup Equipment Needed:	Long walk to site through woods

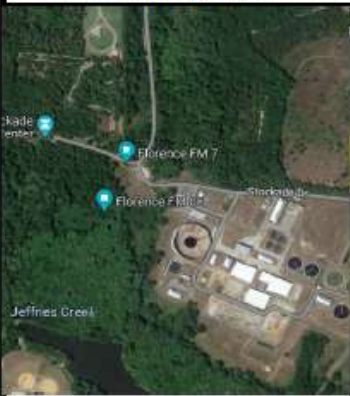
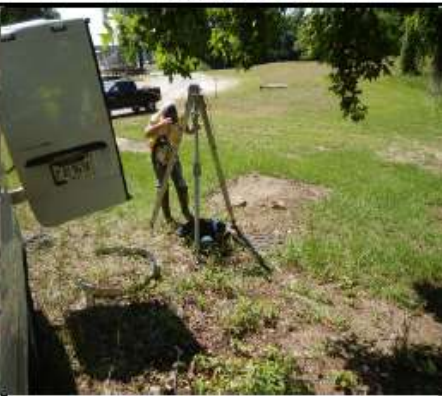
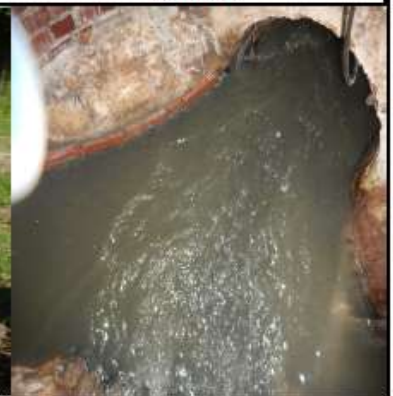
Figure A: Installation Sheet for Flow Monitors for 2023

METER	Time:	UDepth	PDepth/UDepth	PDepth/UDepth	METER	Depth (in)	13.56			Velocity (fps)	2.17			Flow (MGD)	3.02			MANUAL	Depth (in)	13.5			Velocity (fps)	2.22		
METER	Time:	UDepth	PDepth/UDepth	PDepth/UDepth																												
METER	Depth (in)	13.56																														
	Velocity (fps)	2.17																														
	Flow (MGD)	3.02																														
MANUAL	Depth (in)	13.5																														
	Velocity (fps)	2.22																														
Sensor S/N: 174627	Physical Offset: 0 Electronic Pdepth: 0.51																															
Sensor Location: Downstream	Silt: 0 Level Adj: Udepth: 0																															
Velocity Direction: NA	Vel Max fps: Manual Velocity Profiling																															
Data collection interval: 5 Minutes	Velocity Gain: 1																															
Calc. Manual Velocity:																																
Telemetry																																
Telemetry Used: Yes / No		Coordinates: 34° 10.448 79° 45.089		Ant. Type Puck																												
Ant. Location: Next to MH																																
Setup Equipment Needed:																																
LOCATION MAP		LANDSCAPE		SENSOR

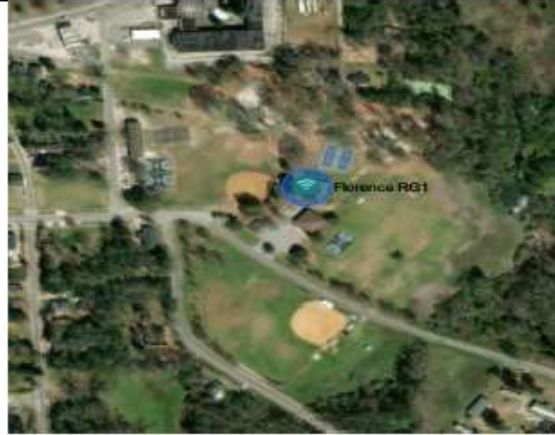
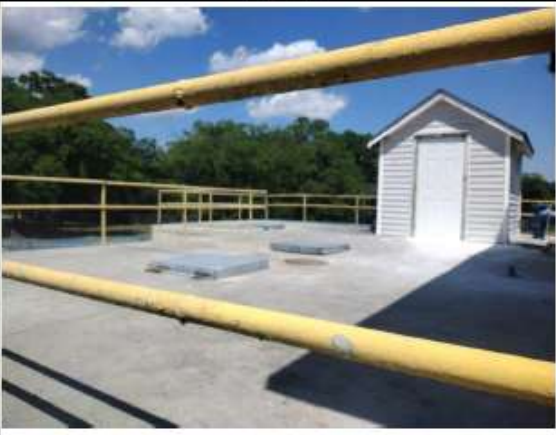
Project Name: COL Flow Monitoring Install Date: 5/24/2023
Rain Gauge Name: Florence RG1 (1 OF 2) Time: 2:00 PM
Site I D: RG2 Installers Initials: BK, SC
Removal Date: _____

Location Description: <u>Roof of Water Treatment Plant 16 Levy Park</u>	
Building Contact Person: _____	
Title: _____	Telephone Number: _____
Instructions for access: _____	
Rain Gauge Hardware Information	Communication/Access Information
Logger Type: <u>Telog RG-32A</u>	Telemetry Used: <u>Yes or No</u>
Logger Serial #: <u>23209945</u>	IP Address: _____
Logger Location: <u>Roof</u>	Antenna Location: <u>Internal</u>
Bucket Type/SN: <u>T.E. 83296-0420</u>	Tip Test at Install (Y/N) <u>Y 5</u>
Bucket Location: <u>Roof</u>	Ladder necessary for bucket access (Y/N) <u>N</u>
Data Collection Interval: <u>5 Minutes</u>	Ladder necessary for logger access (Y/N) <u>N</u>
LOCATION MAP	PHOTO

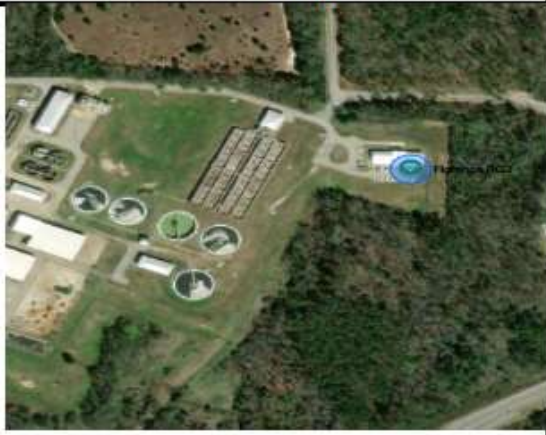
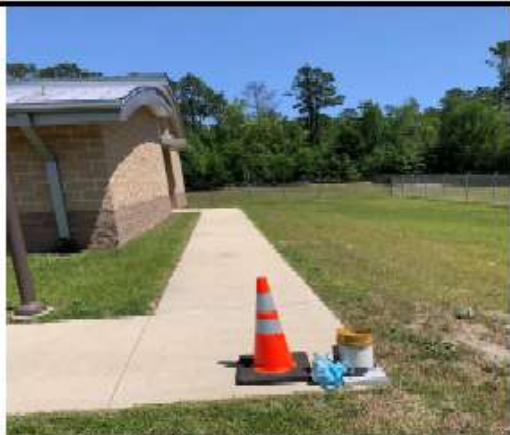
Figure B: Installation Sheet for Rain Gauges for 2023

Project Name: COL Flow Monitoring Install Date: 5/24/2023
 Rain Gauge Name: Florence RG2 (2 OF 2) Time: 1:00 PM
 Site I D: RG2 Installers Initials: BK, SC
 Removal Date: _____

Location Description: <u>South sidewalk of WWTP Admn. Bldg.</u>	
Building Contact Person: _____	
Title: _____	Telephone Number: _____
Instructions for access: _____	
Rain Gauge Hardware Information	Communication/Access Information
Logger Type: <u>Telog RG-32A</u>	Telemetry Used: <u>Yes or No</u>
Logger Serial #: <u>34200917</u>	IP Address: _____
Logger Location: <u>Sidewalk</u>	Antenna Location: <u>Internal</u>
Bucket Type/SN: <u>T.E. 86745-0521</u>	Tip Test at Install (Y/N) <u>Y 5</u>
Bucket Location: <u>Sidewalk</u>	Ladder necessary for bucket access (Y/N) <u>N</u>
Data Collection Interval: <u>5 Minutes</u>	Ladder necessary for logger access (Y/N) <u>N</u>
LOCATION MAP	PHOTO

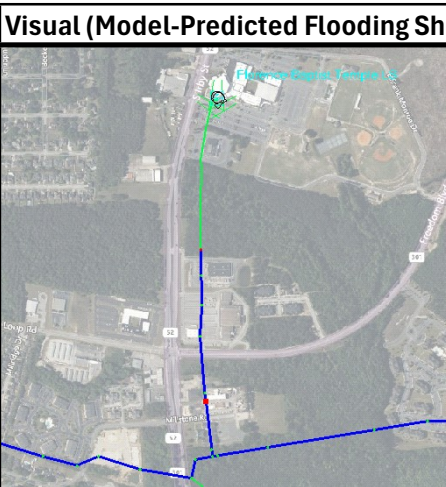
ID	Label	Location	Visual (Model-Predicted Flooding Shown in Red)
9204, 10077	swr-mh-534, swr-mh-3202	D/S of Florence Baptist Temple

Unconfirmed Model-Predicted Capacity Limitations

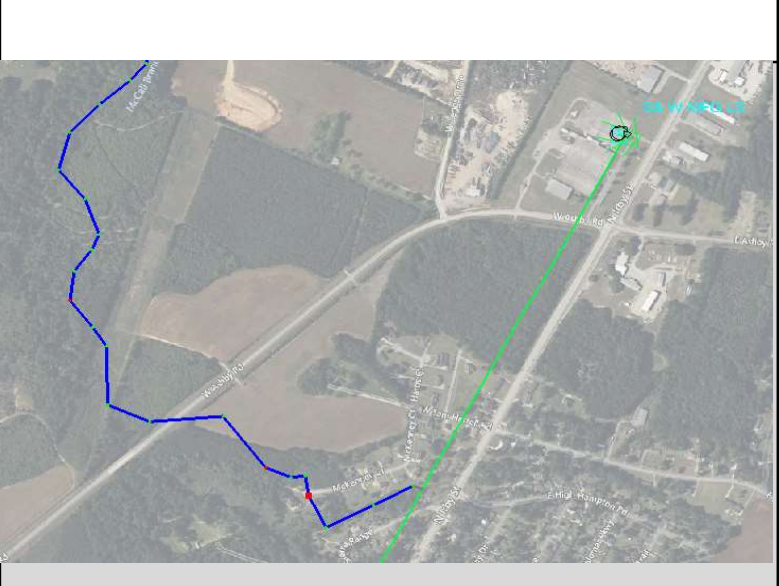
9621, 9169, 9319	swr-mh-7571, swr-mh-4838, swr-mh-5641	McCall Branch Interceptor

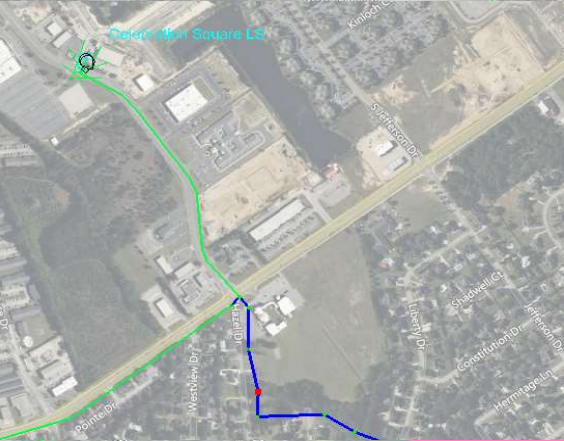
9874	swr-mh-2444	DS of Celebration Square LS

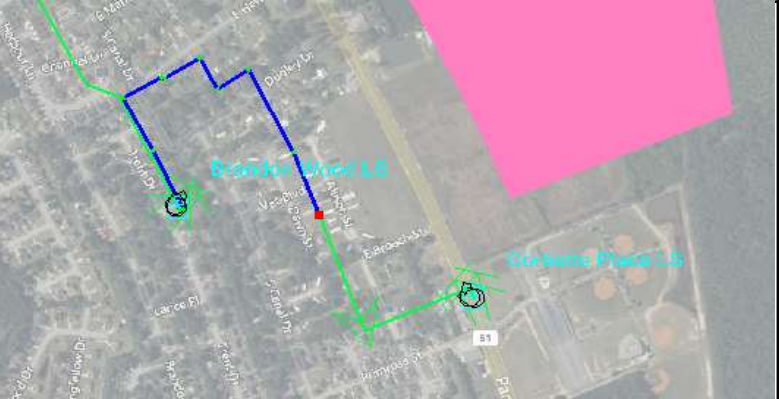
9225	swr-mh-5488	Corbette Place LS forcemain outlet
